## **Snowmass Mountain Condominiums Construction Update Week 15 July 24 - 31, 2011**

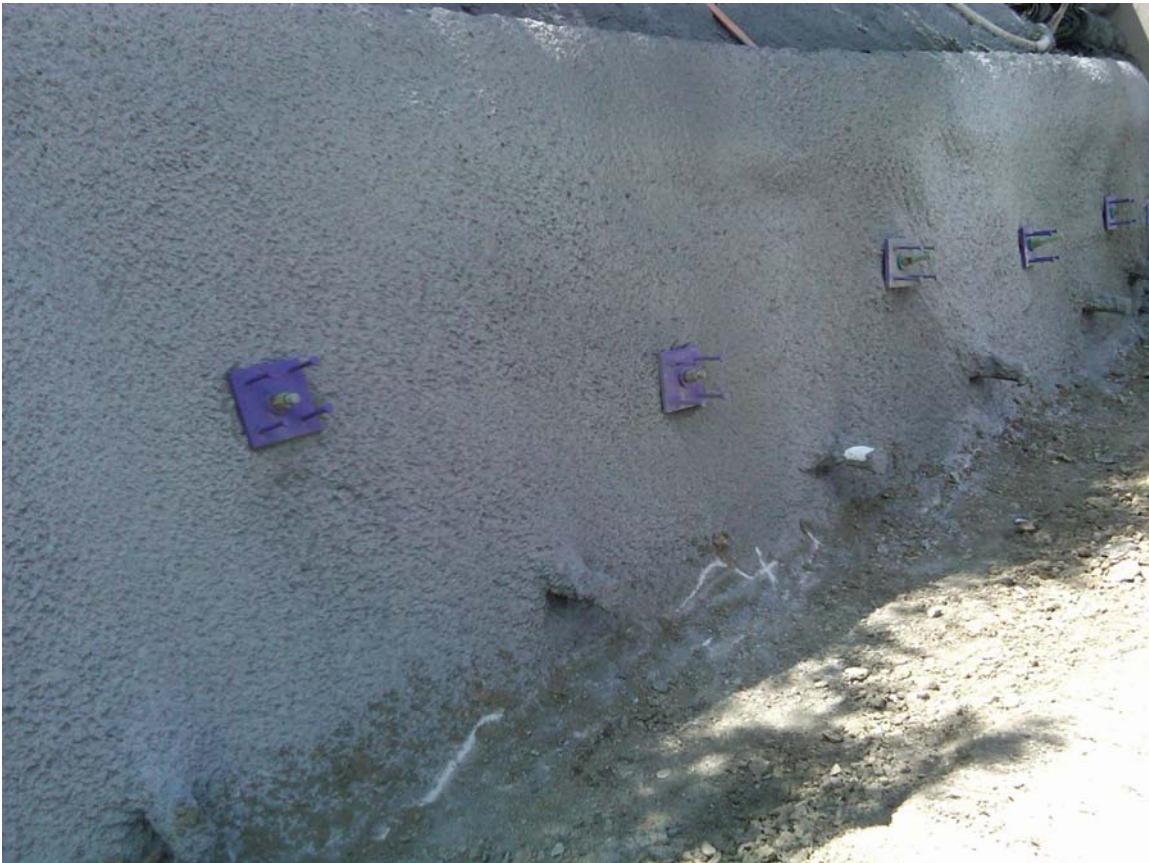
The first picture shows the "shot-crete" along the new entryway to the complex. This technique uses soil nails (see the purple squares and the giant nails below) that are driven into bedrock to hold up the 8" thick concrete wall against the soil. The current ugly industrial look of the wall, when completed, will be surfaced with a nice stacked-stone finish. The area above the wall will be terraced, and plentiful landscaping is planned for the entrance area. Landscaping will be tackled in earnest in 2012.

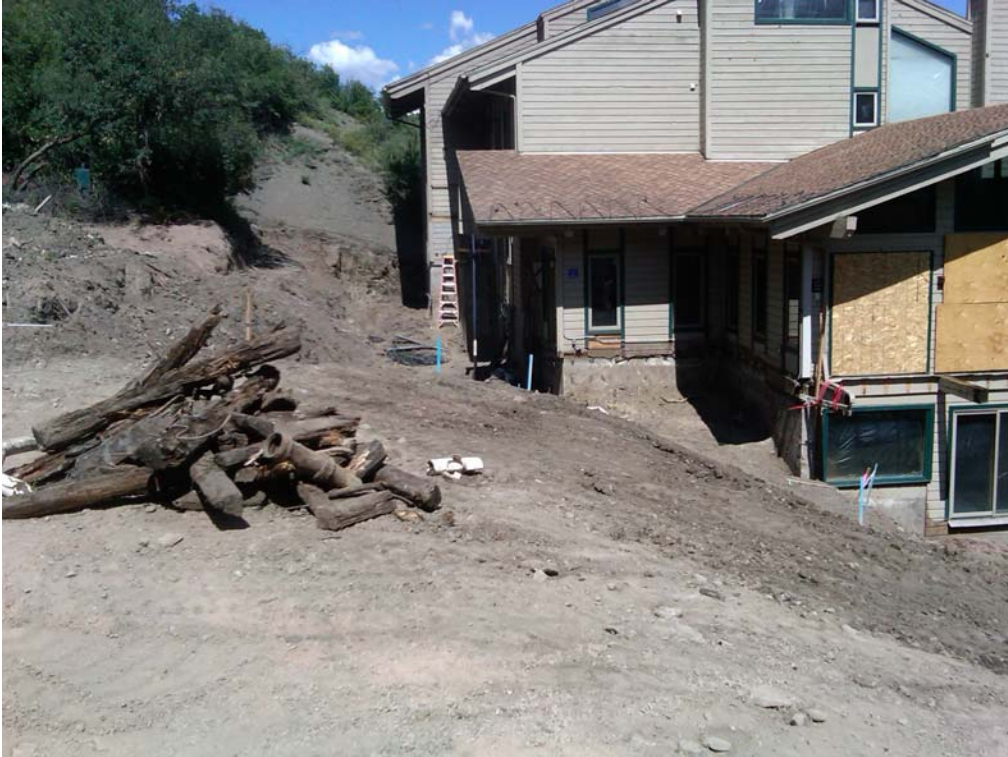
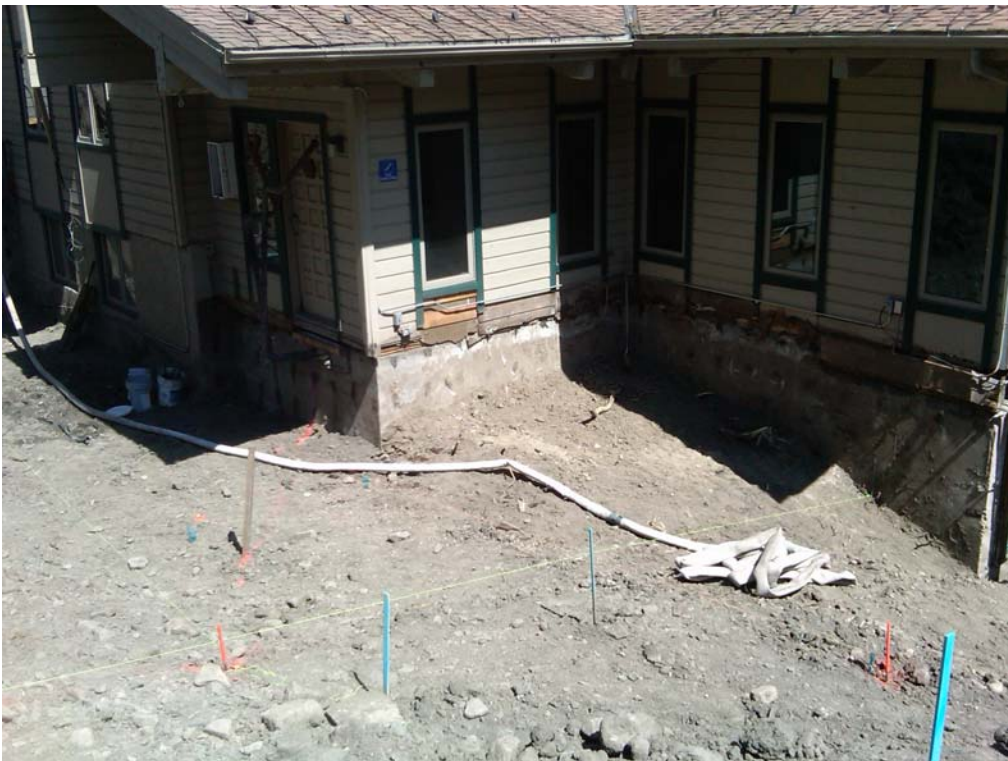
Hank wrote that the week saw a lot of heavy equipment on the job site again. The area around the office complex in Building A was one focus of work. The next two pictures show where the old pond and planter used to be; they have been removed from in front of the office. Not only was the old grading there problematic, but too much dirt right next to the building had allowed water to run into the siding of the building over the years. The new, expanded driveway with a bus turn-around in that area will compress

the amount of space between the parking lot and the entrance to the office, and a complete redesign of the entrance, stairs, and landing going into the office area is underway. This is another area the Landscaping Committee has designated as a priority for work in the future.

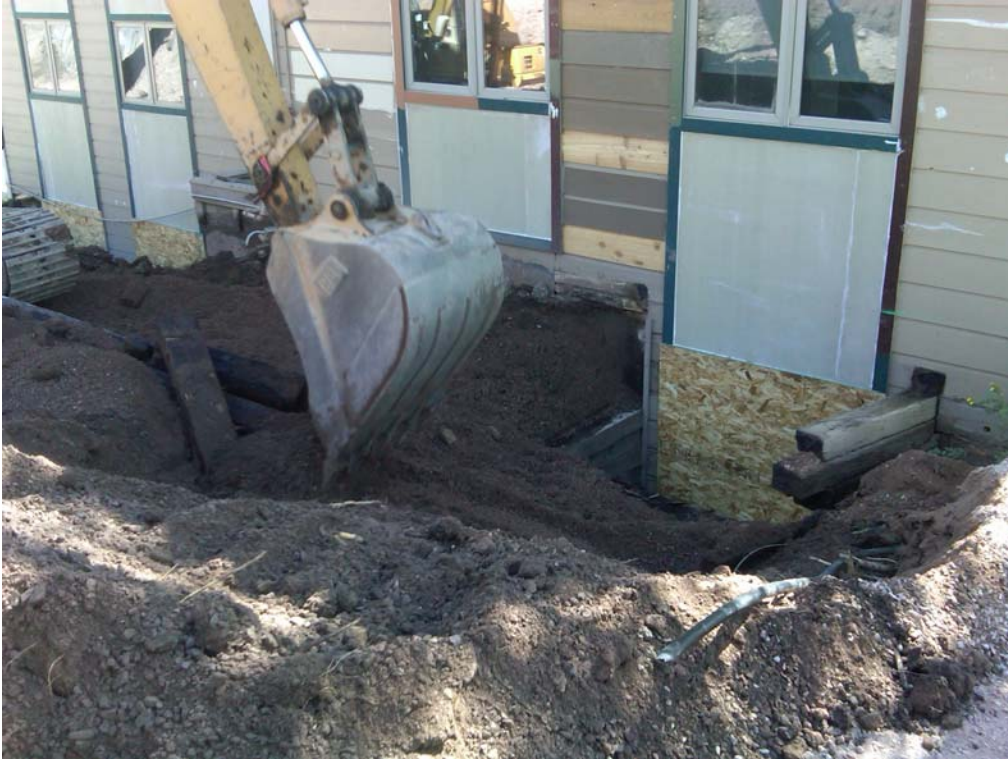
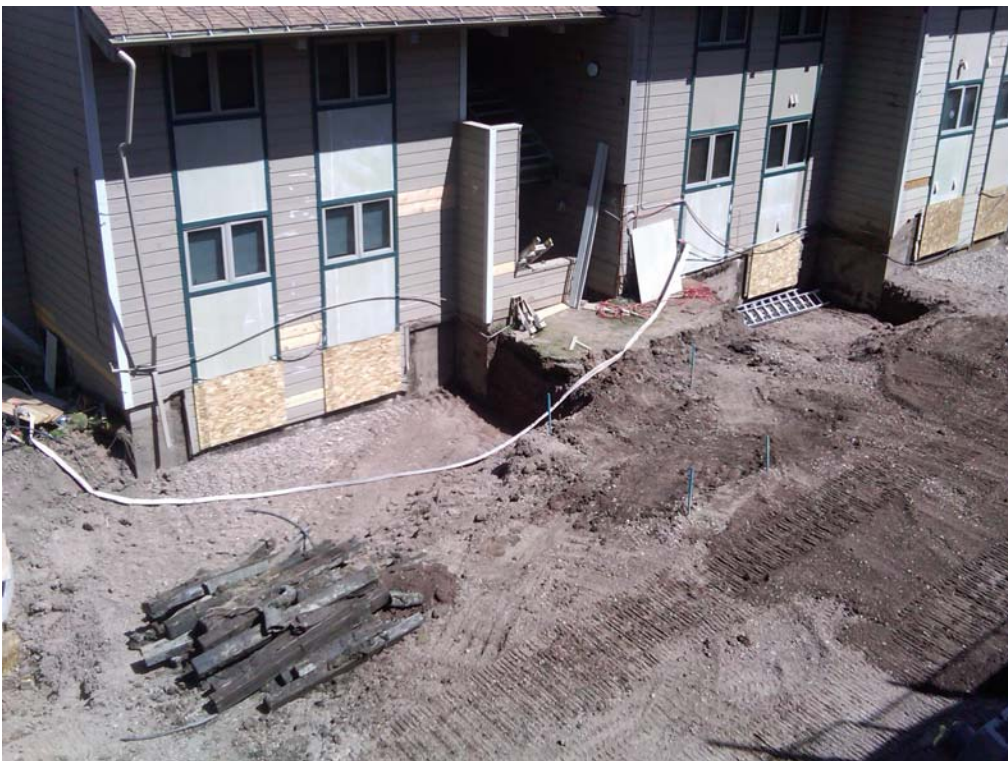
The week also saw the removal of all the old window wells on the lower buildings in preparation for new MSE window wells. The next two pictures show this work going on at Building J right outside our unit! Glad I wasn't there during this work.
